TREE INVENTORY

LANDSCAPE MASTER PLAN

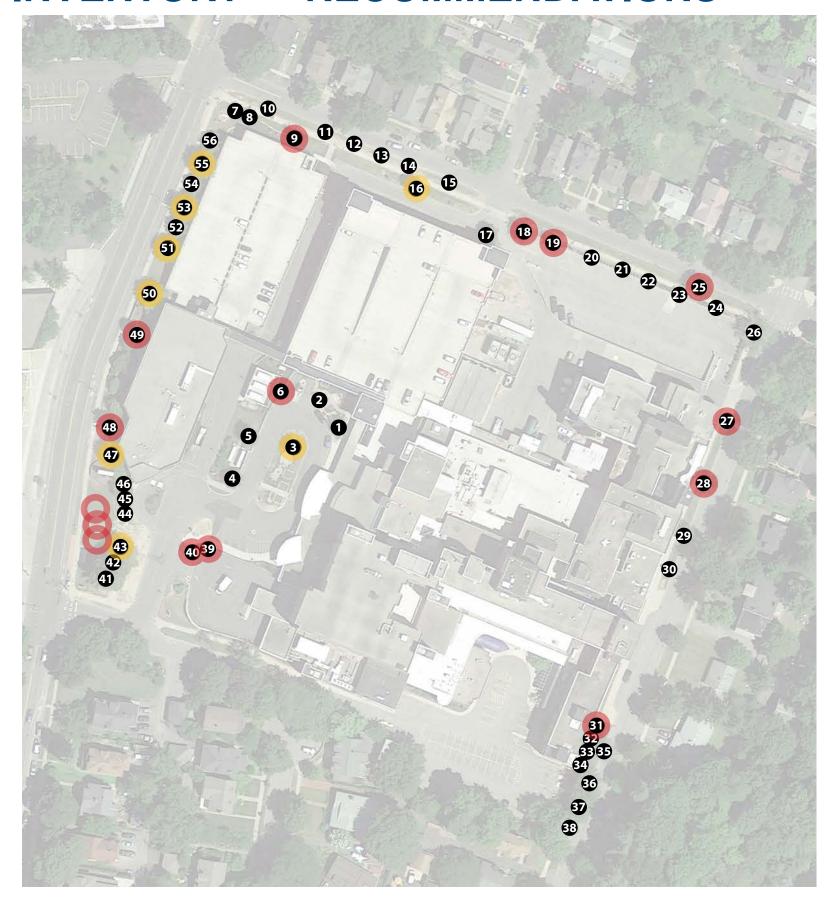
TREE INVENTORY — RECOMMENDATIONS

- TREE TO REMAIN
- TREE TO REHABILITATE
- TREE TO REMOVE

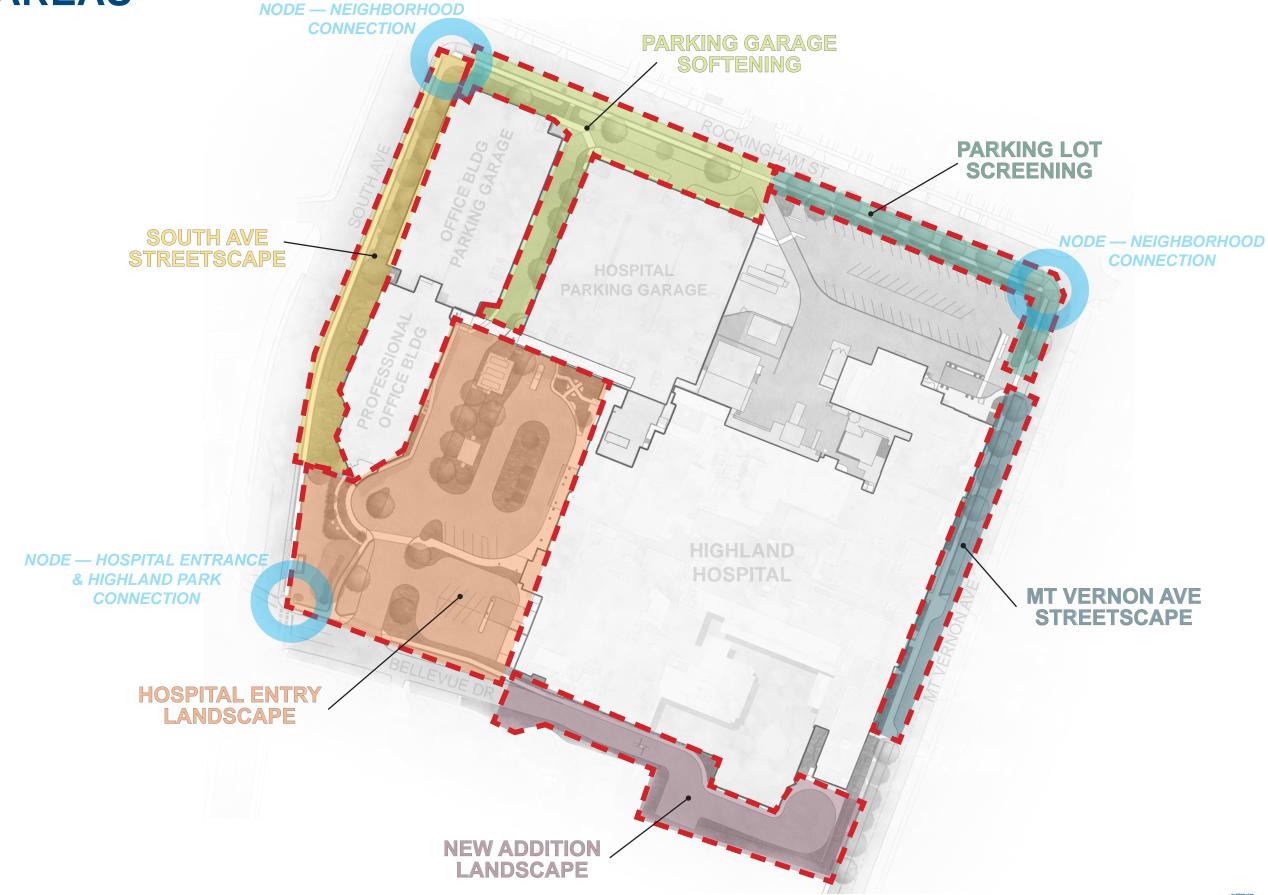
KEY AREAS

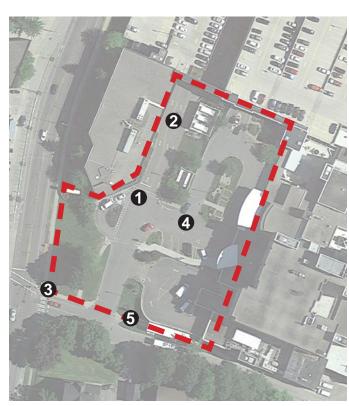
HOSPITAL ENTRY LANDSCAPE

EXISTING CONDITIONS

- Confusing pedestrian circulation increases risk of conflict with vehicles
- Sidewalk connection to parking garages needed
- **3** Weak connection to Highland Park across the street
- 4 Lack of shade trees makes for a harsh paved landscape
- 6 Hospital staff sit on street curbs during breaks

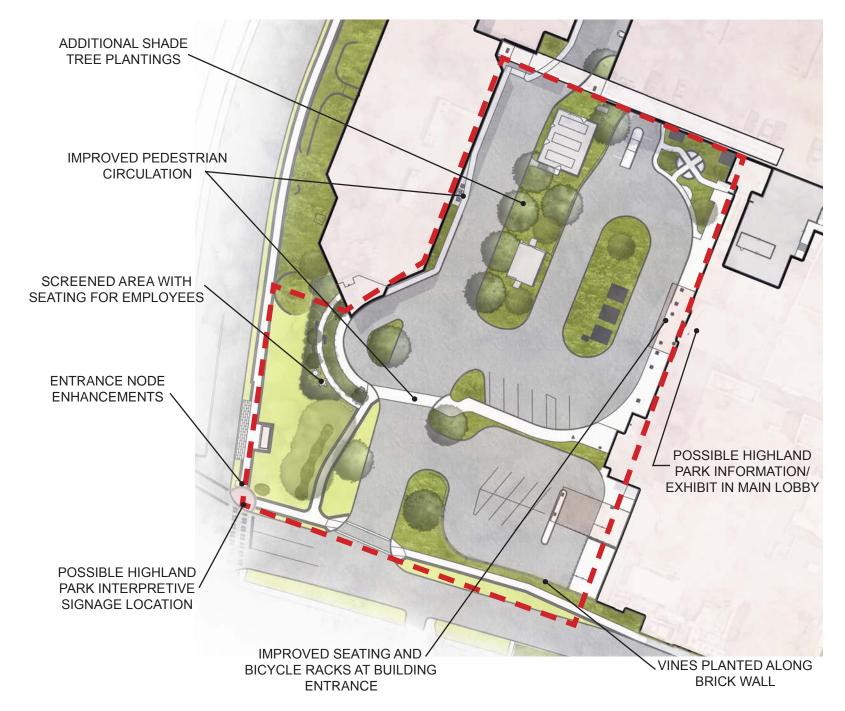
RECOMMENDED STRATEGIES

- Create an attractive first impression
- Improve pedestrian circulation
- Incorporate shade trees wherever possible
- Develop connections to Highland Park
- Provide a space of respite for hospital employees
- Enrich landscape with diverse low-maintenance plantings
- Reduce the amount of maintenance required to keep lawn in good health

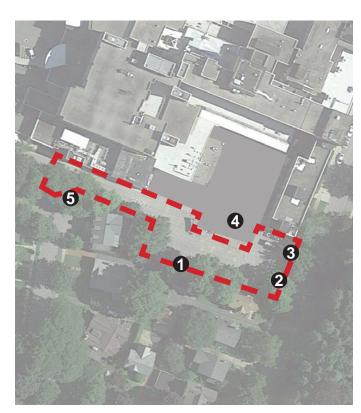
NEW ADDITION LANDSCAPE

EXISTING CONDITIONS

- Gaps in screening vegetation expose residential backyards to hospital
- 2 Limited screening plantings exist along Mount Vernon Avenue
- 3 Existing plantings have very little seasonal interest
- 4 Landscape around new building needs to blend in with existing surroundings
- **6** Gaps in understory vegetation expose the Bellevue cul-de-sac to hospital

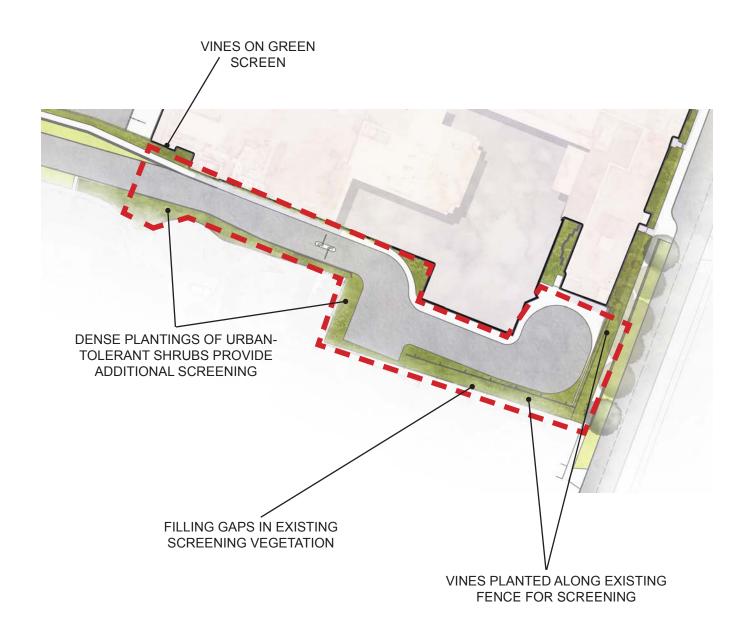
RECOMMENDED STRATEGIES

- Screen buildings from adjacent neighborhood (visual and auditory)
- Accommodate snow storage needs
- Incorporate low-maintenance plantings that provide yearround interest

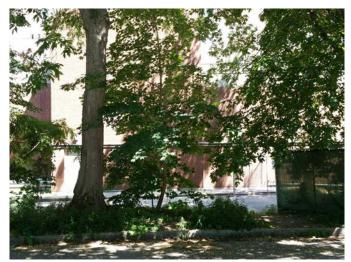
existing vegetation screens much (but not all) of the hospital from view of the adjacent neighborhood

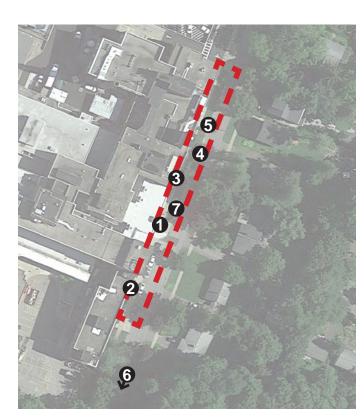
MT VERNON AVE STREETSCAPE

EXISTING CONDITIONS

- Underwhelming entrance to the Oncology Center
- Poundation plantings lack seasonal interest
- **3** Building facade is out of scale with residences across the street
- Damage to turf grass along sidewalk from winter salting and plowing
- **6** Gaps in street tree plantings
- **6** Connection to Olmsted portion of Highland Park
- Smokers on the sidewalk are a neighborhood concern

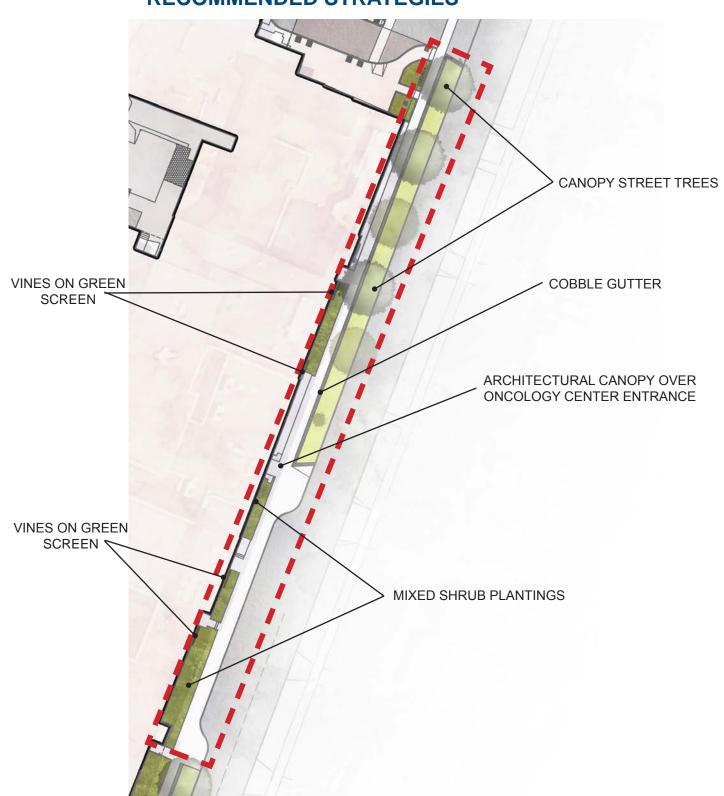
RECOMMENDED STRATEGIES

- Fill gaps in the tree lawn
- Enhance Oncology Center entrance
- Visually break up expansive building facade
- Reduce the amount of maintenance required to keep lawn in good health
- Acknowledge connection to Highland Park

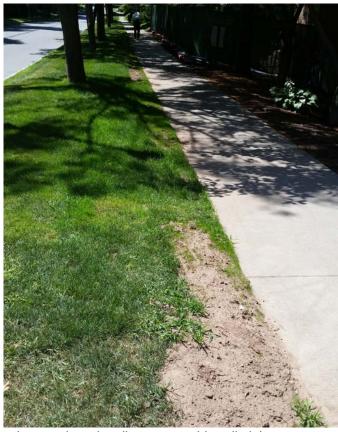
wherever lawn is adjacent to a sidewalk, it is common to see turfgrass damaged by winter plowing and salting

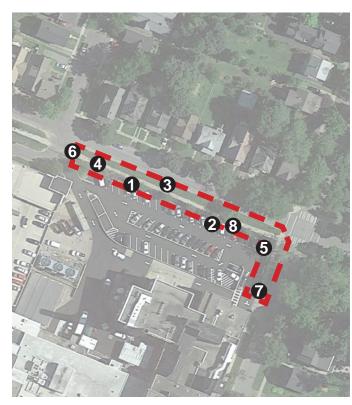
PARKING LOT SCREENING

EXISTING CONDITIONS

- 1 Limited screening of parking lot from the adjacent neighborhood
- 2 Major die-off of arborvitae recently planted to screen parking lot
- Many potential planting spots for street
- 4 Turf grass along sidewalk damaged from winter salting and plowing activities
- 6 Limited locations for storing plowed snow in winter
- 6 Truck traffic creates ruts in lawn
- Smokers on sidewalk are a neighborhood concern
- 6 Litter & cigarette butts collect in planting beds

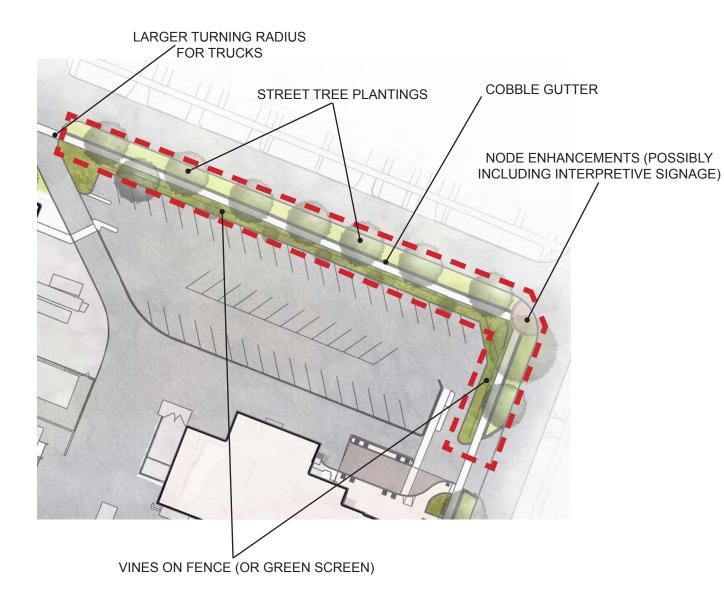
RECOMMENDED STRATEGIES

- Fill gaps in tree lawn
- Screen parking lot
- Repair sidewalks as needed
- Improve pedestrian circulation
- Reduce the amount of maintenance required to keep lawn in good health
- Accommodate snow storage needs

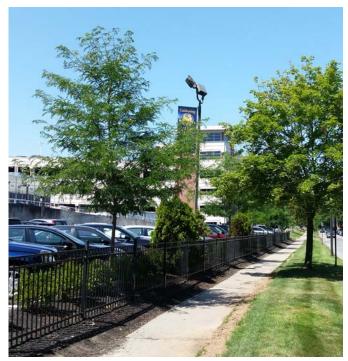
existing vegetation does little to screen the parking lot from the adjacent neighborhood

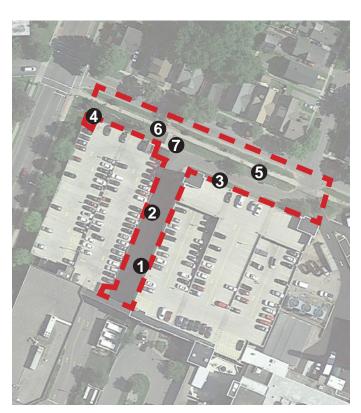
PARKING GARAGE SOFTENING

EXISTING CONDITIONS

- Drive between parking structures creates canyon effect
- 2 Sidewalk needed for pedestrian circulation
- 3 Large parking structures out of scale with residences across the street
- 4 Sparse plantings with limited seasonal interest do little for the landscape
- **6** Damage to turf grass along sidewalk from winter salting and plowing
- 6 Smokers on sidewalk are a neighborhood concern
- Litter & cigarette butts collect in planting beds

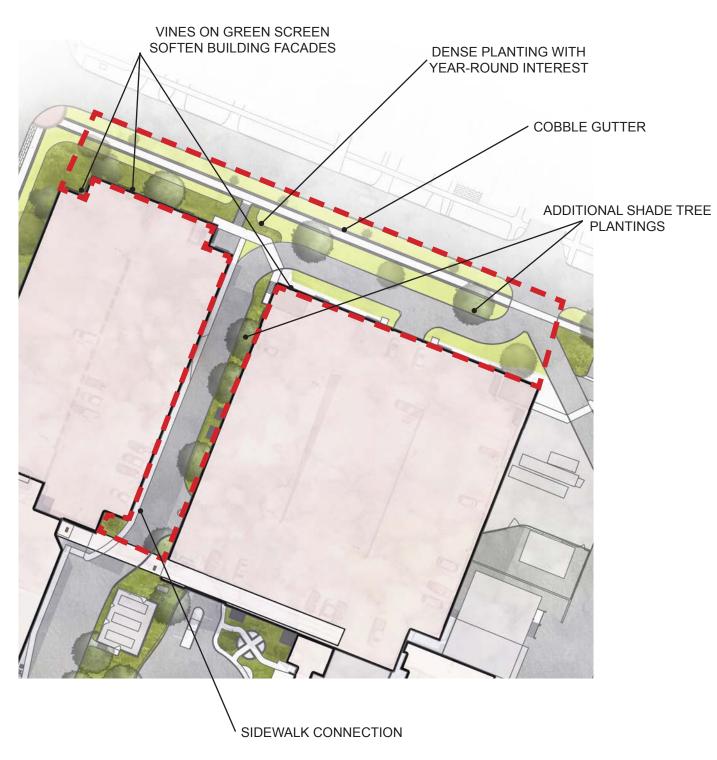
RECOMMENDED STRATEGIES

- Fill gaps in tree lawns
- Soften the scale of large parking structures
- Incorporate diverse plantings at staircase that provide yearround interest
- Improve pedestrian circulation
- Reduce the amount of maintenance required to keep lawn in good health

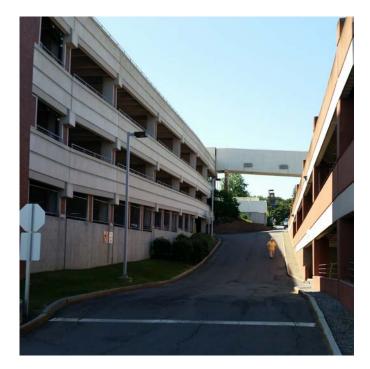
there is a need for a sidewalk between the two parking garages

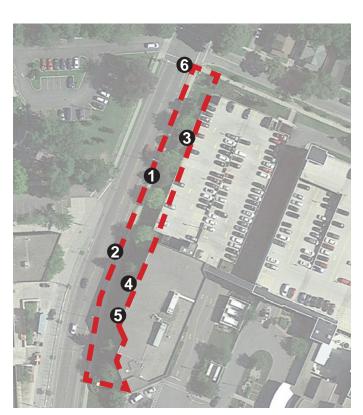
SOUTH AVE STREETSCAPE

EXISTING CONDITIONS

- Turf grass along sidewalk damaged from winter salting and plowing activities
- 2 Turfgrass in narrow lawn strip between sidewalk and street growing poorly
- **3** Existing trees currently in good health, but at-risk for future issues
- Monotonous plantings offer little seasonal interest
- **6** Concrete block retaining walls at end of lifespan and less than ideal for a quality
- institutional landscape
- Major crossing for kid and parents walking to school

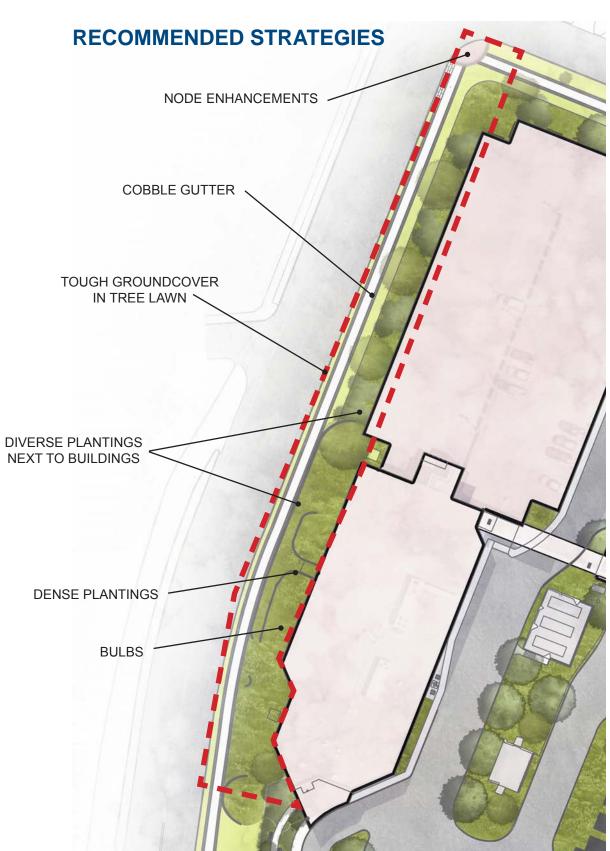
- Fill gaps in existing vegetation to help screen buildings
- Provide diverse plantings on slope to provide seasonal interest
- Screen concrete block retaining walls with plantings
- Reduce the amount of maintenance required to keep lawn in good health

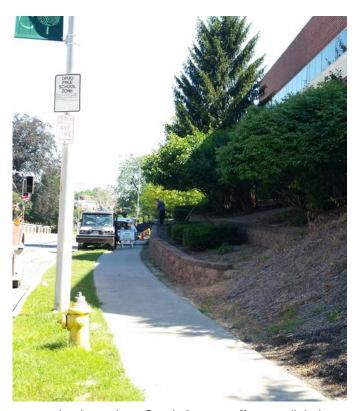
plantings along South Avenue offer very little in terms of seasonal interest

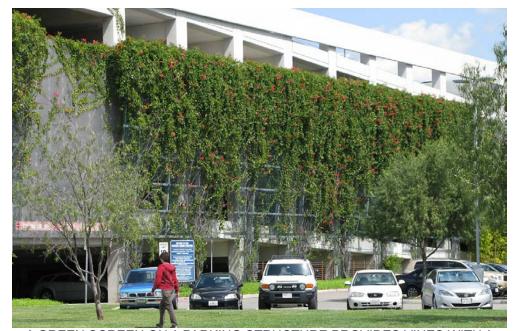
A GREEN SCREEN ON A PARKING STRUCTURE PROVIDES VINES WITH A SUPPORT ON WHICH TO GROW. WHEN MATURE, THE VINES HELP SCREEN THE PARKING STRUCTURE FROM VIEW.

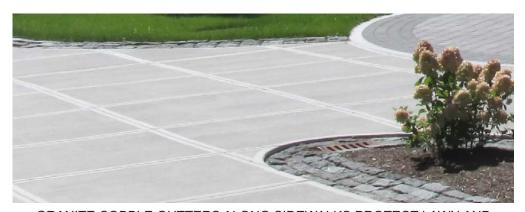
GRANITE COBBLE GUTTERS ALONG SIDEWALKS PROTECT LAWN AND PLANTINGS FROM WINTER PLOWING AND SALT DAMAGE

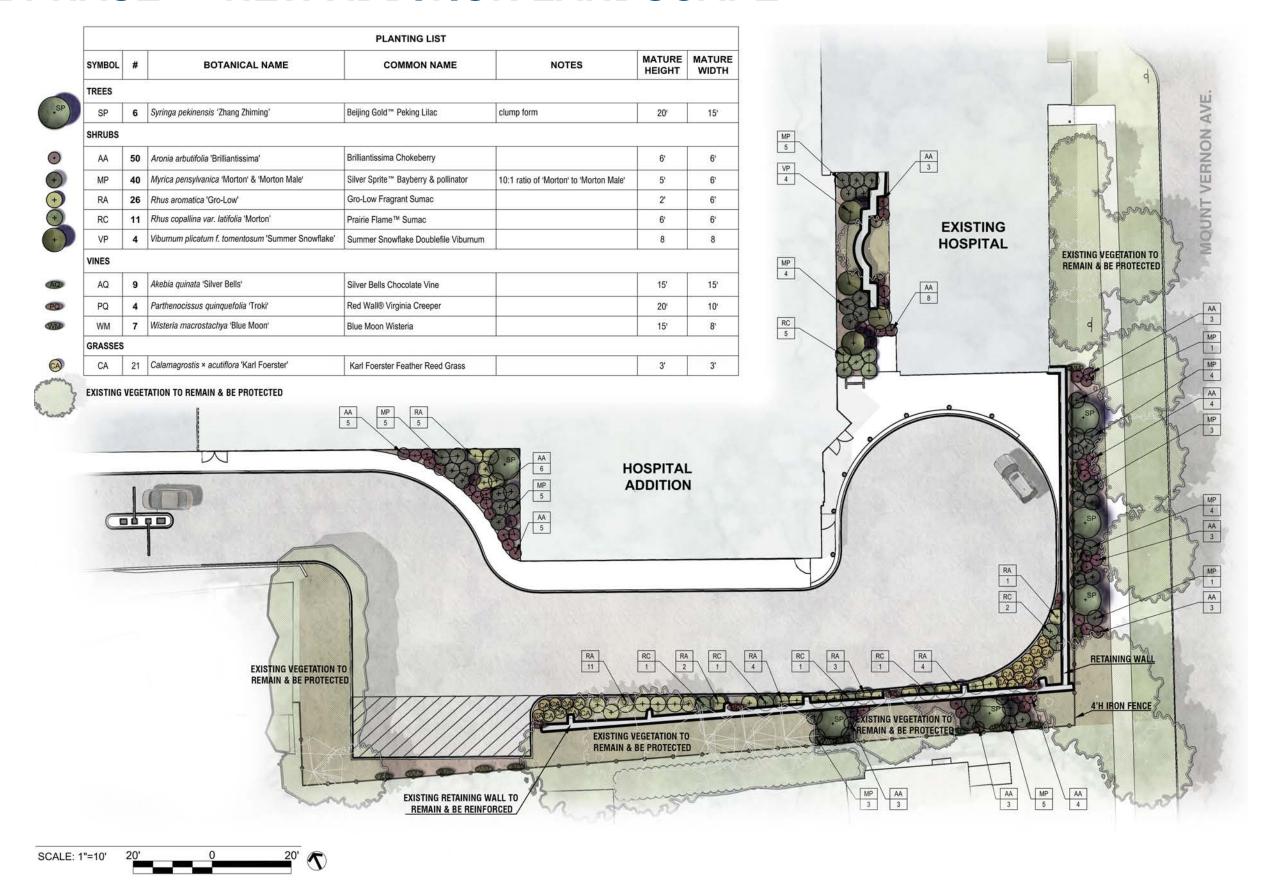
INITIAL PHASE — NEW ADDITION LANDSCAPE
